TE 92515

Title: Ad-hoc fire test on a Metaloterm MF chimney system when subjected to an internal fire.

Client: Ontop BV,
Oude Veerseweg 23,
4332 SH Middelberg,
Nederland.

Date: 6 September 1999

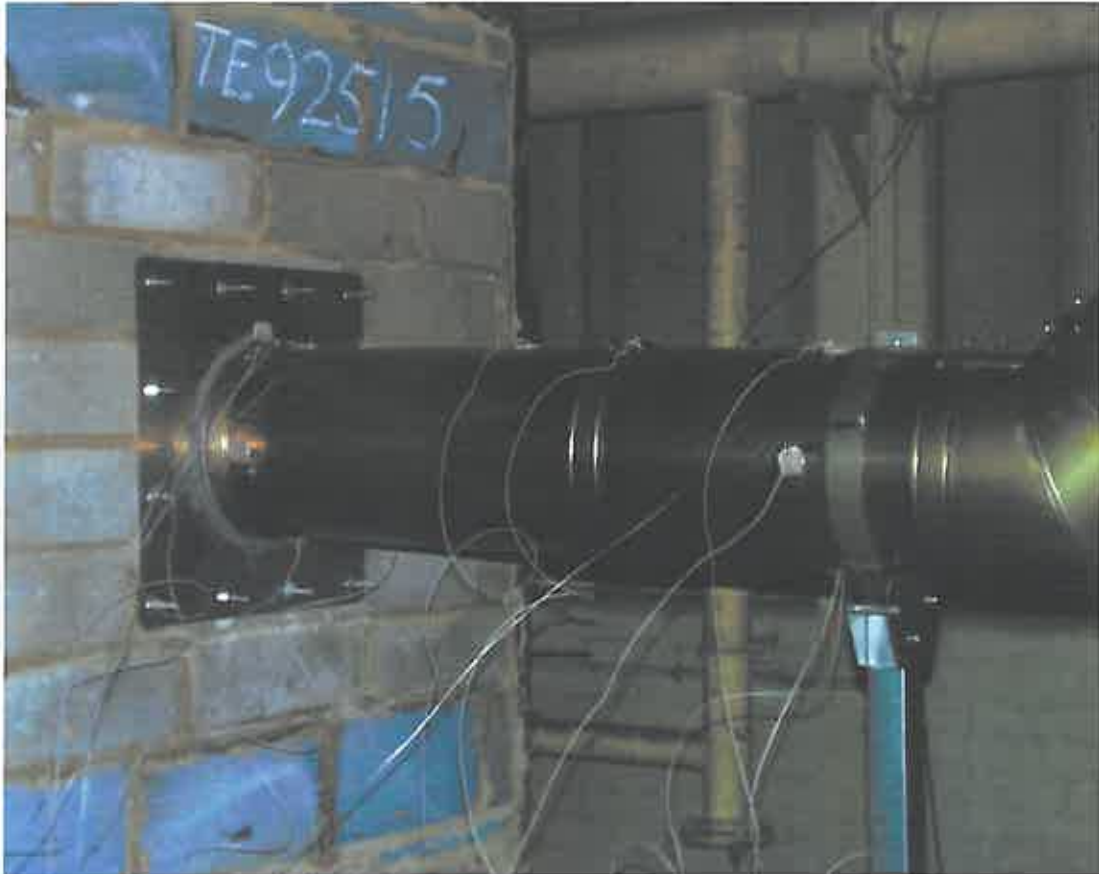
**Plate 5 Chimney and penetration seal immediately after furnace shutdown
at 246min**

The chimney is shown after the test in Plates 5 and 6.
